## Research Article

# Shear Strengthening of Recycled Lightweight Coarse Aggregate Concrete Beams Using NSM Technique

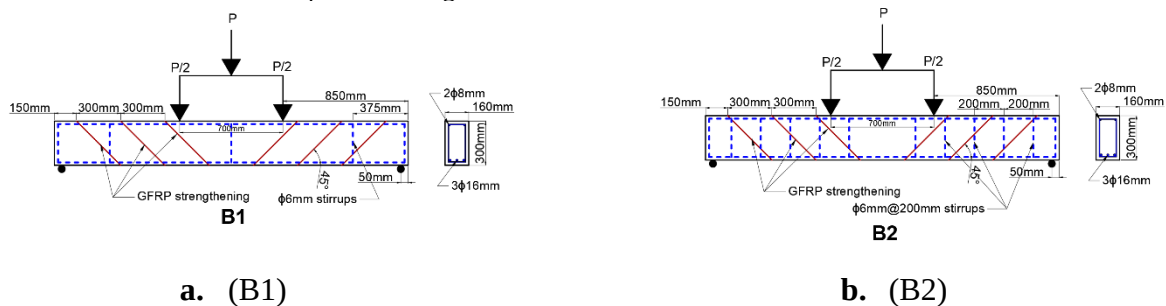
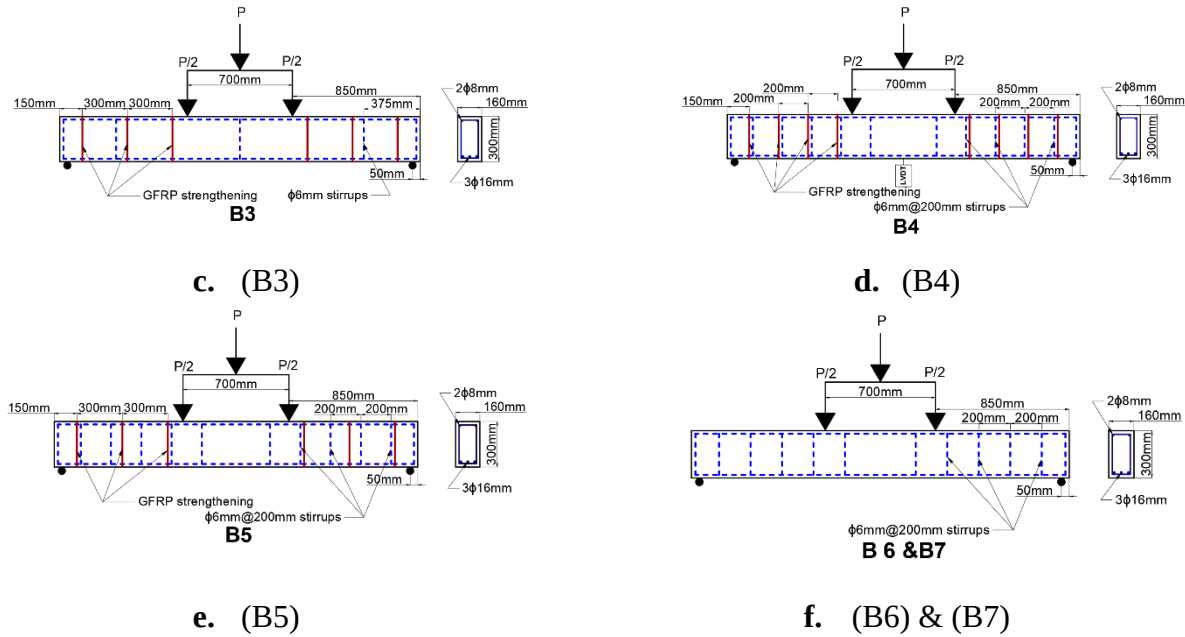
Fig. 1. Details of used beams in the test

In this study, seven beams were tested with a length of 2400mm, 160mm width and 300mm height. Two of them remained without strengthening. The first one was cast with normal concrete and the second was cast with 30% bonza coarse aggregate replacement ratio to compare the beam failure mode and the decrease in the load carrying capacity due to partial replacement of natural aggregate with bonza. The remaining five beams were cast with 30% coarse aggregate replacement ratio of bonza (volumetric ratio), two of them which do not contain stirrups. The beams were designed to have a high flexural capacity to ensure the failure occurs in the shear zone. Three 16mm bars (had a 580MPa yield strength) were used as reinforcement for flexural, and 6mm stirrups bar (250MPa yield strength) @200mm, with two 8mm (420MPa yield strength) top bars. The loading system was four-point bending load, the details of beams and loads are shown in Figure 1. All beams had the same longitudinal reinforcement but differed in the presence or absence of stirrups. Five styles of Near-Surface Mounted (NSM) strengthening configuration were used for shear strength by (GFRP) bars, the diameter of the used (GFRP) bars was 6mm. The models also differ in the style of strengthening configuration, there were five different patterns. The first pattern was inclined strengthening without stirrups, the second type was inclined strengthening with stirrups, the third one was vertical strengthening with a distance of 300 mm without stirrups, the fourth type was vertical strengthening with a distance of 200 mm with stirrups and the fifth type was vertical strengthening with a spacing of 300 mm with stirrups. One of the beams remained without strengthening, as shown in table 1 and Figure 1. beam specimens were loaded under a four-point loading system as simply supported beams as shown in Figure 1. The load was increased until failure of beams. The deflection at mid-span was collected by using LVDT, while the strains were recorded by data acquisition.

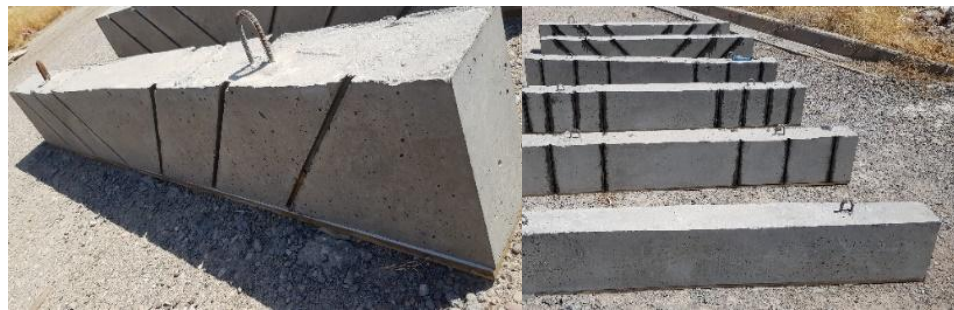
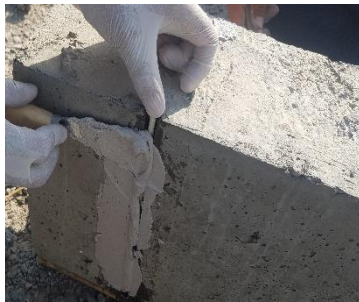
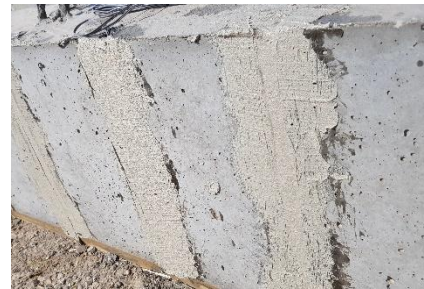
Fig. 2. Stages of installing GFRP bars

To strengthen the beams using the NSM technique, (6 mm) diameter GFRP bars were used, with (400 MPa) breaking strength. Five patterns of configuration have been used to strengthening the beams, while the reference beams have not been strengthened for sake of comparison, as shown in Figure 1 and table1. The NSM technique that has been used in this research was done as follows: Firstly, grooves of (12\*12mm) were made on both sides of the beam according to the specific locations, a thin layer applied on the grooves of primer base (which consists of a mixture of two materials produced by the DCP company), then it was left for 24 hours to dry. Then the GFRP bars were glued to the surface of the beams with an adhesive designated (Sikadur-31) was used as an adhesive to attach the GFRP bars to the concrete surface as a second layer (it was applied in the form of a 2-component thixotropic epoxy adhesive). The grooves that the GFRP rods installed into them were filled. Figure 2 shows pictures of the installation stages of the GFRP rods on the beams.

a. Making the grooves

b. Applying layer of primer

The GFRP bar was glued by sikadur-3

d. Finishing beam surface

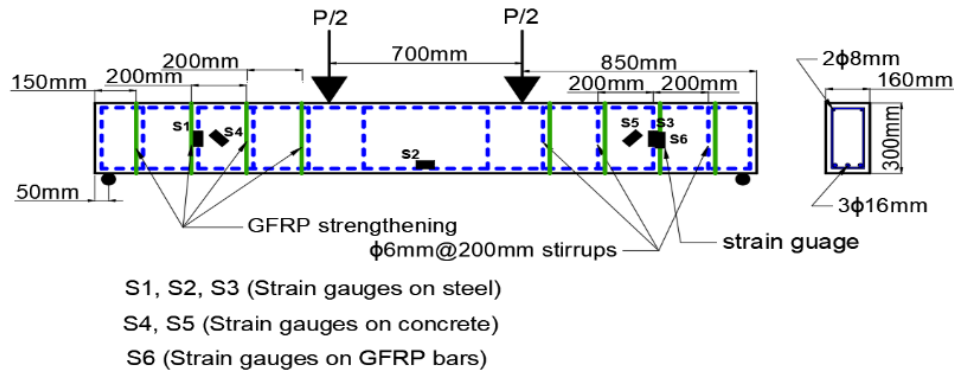
Fig. 3. Locations of strain gauges on a typical tested beam.

Two types of strain gauges (Tokyo Measuring Instruments Lab.) were used. The first type was mounted to the steel with a length of (5 mm) and the other type was applied on concrete surface with a length of (30 mm) with their adhesives obtained from the same corporation. Strain gauges were fixed at six locations of the beam, as shown in Figure 3. Two of them were mounted to the stirrups at the left and right sides of the beam, and one was mounted to the middle of main longitudinal reinforcing steel bar, two were mounted on the concrete surface at the shear zone. They were inclined at an angle of 45° normal to the direction of the shear cracks. The last strain gauge was fixed on one of the GFRP bars. The data were collected by the (data acquisition) that was connected with the computer and the strains were recorded during the test for all stages of loading.

As previously mentioned, the strain gauges have been placed at six locations on the beams as shown in Figure 3. Table 7 shows the value of strain that has been recorded at failure load of each beam.

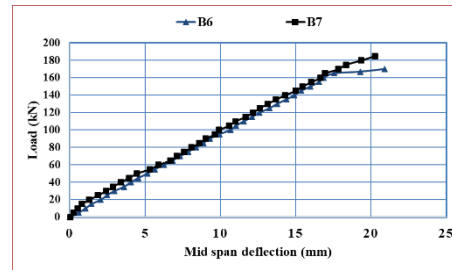
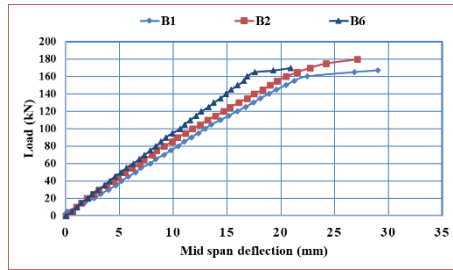
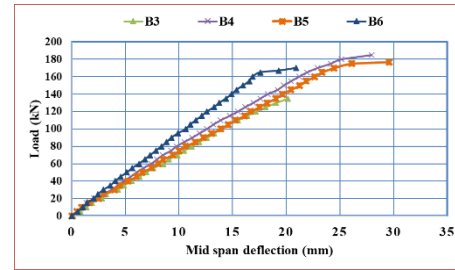
Fig. 4. Load deflection relationships of tested beams.

All the deflections were measured up to the failure load, the location of the (LVDT) was at the midspan of the beams. Figure 4 shows the load versus mid-span deflection of the tested beams. Although the beams strengthened with GFRP bars had a maximum loads larger or smaller than the beam B6, all the maximum deflection of these beams was greater than the maximum deflection of the unstrengthened beam (B6), as shown in table 6. By observing Figure 4-a, it is evident that the deflection of beams B6 and B7 (which were tested without external strengthening) were identical to a large extent at all stages of loading. This gives an indication that the response of a beam that contains 30% of bonza lightweight aggregates has a behavior similar to that of a beam that cast with normal concrete. Beams B1 and B2, that had been strengthened with 45o inclined GFRP rods, had a deflection higher than the beam B6 at all loading stages. The same is true for beams B3, B4 and B5 (which have been strengthened with vertical GFRB rods), the deflection of which is greater than that of the beam B6 for all loading stages, Figure 4-b and c.

a. Load deflection curves of unstrengthened beams (B6 and B7)

Load deflection curves of beams B1, B2 and load deflection curves of beams B3, B4, B5 and B6

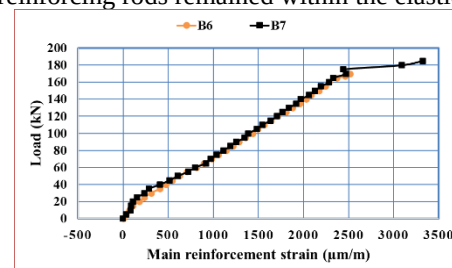
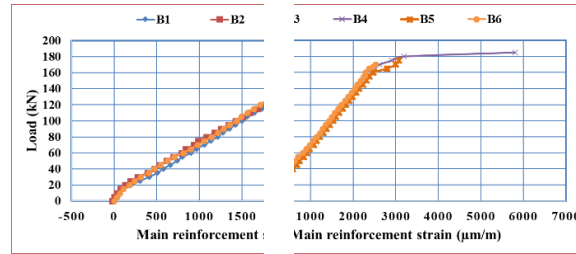
Fig. 4. Load-steel strain relationships at mid-span of longitudinal bottom rebars.

By noting Figure 5 which illustrates the strains occurring at the main reinforcing rods for all beams, it can be noted that the strains have almost the same pattern as that of the reference path beam which had a linear response until reaching the failure load. This trend can be attributed to the main reinforcement in the beams which was designed to resist high moments and loads. Therefore, the strains in the main reinforcing rods remained within the elastic range.

a. Load-steel strain curves of beams B6 and B7

b. Load-steel strain curves of beams **B1, B2** and **B6**c. Load-steel strain curves of beams **B3, B4, B5** and **B6**

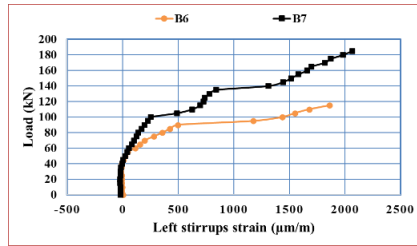
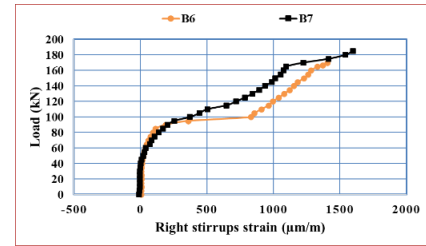
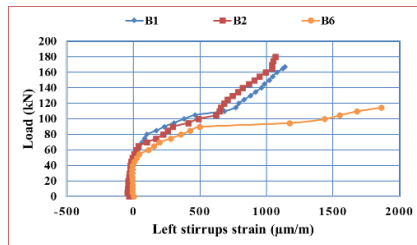
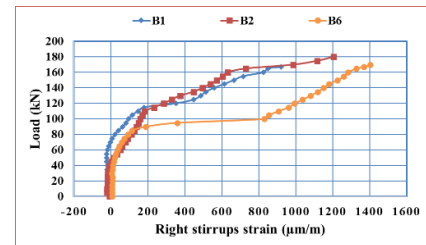
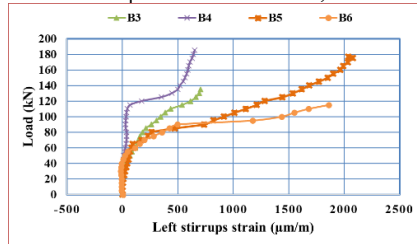
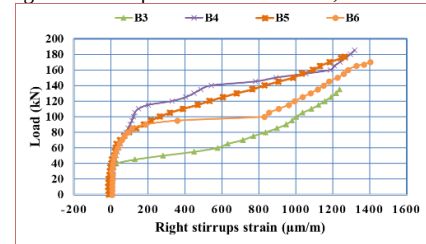
Fig. 5. Load strain relationship at left and right stirrups for tested beams.

For the strain on the stirrups that shown in (Figure 5 a to f). It can be noted that the recorded strain at stirrups was recognized at a load level of about (40-50 kN) approximately, that indicates the beginning of the transferring of loads from the cracked concrete to the stirrups at this stage. These values are close to the values of concrete strength that is calculated using equation (1).

a. Left side stirrups strain for beams **B6** and **B7**.

b. Right side stirrups strain for beams **B6** and **B7**.

c. Left side stirrups strain for beams **B1**, **B2** and **B6**.

d. Right side stirrups strain for beams **B1**, **B2** and **B6**.

e. Left side stirrups strain for beams **B3**, **B4**, **B5** and **B6**.

f. Right side stirrups strain for beams **B3**, **B4**, **B5** and **B6**.

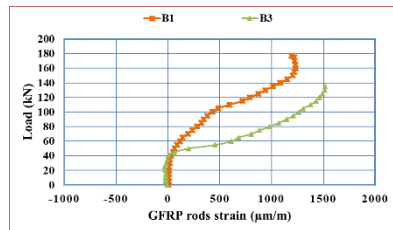
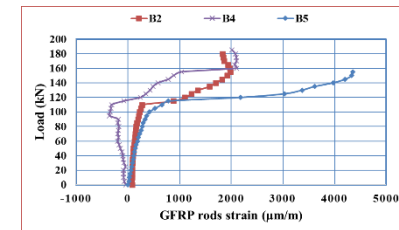
Fig. 6. Load strain relationship of GFRP rods.

As for the strain on the GFRP strengthening rods. It begins to be significant the transfer of loads to the GFRP rods early at load level of about 40 kN for beams without stirrups, (Figure 6-a), and at a loaded of 110 kN for beams that have stirrups, (Figure 6-b). These values of the loads are obtained when adding the values of concrete shear strength that computed using equation (1), with the resistance of the stirrups calculated using equation (2)

a. Load strain curves of beams **B1** and **B3**

b. Load strain curves of beams **B2**, **B4** and **B5**

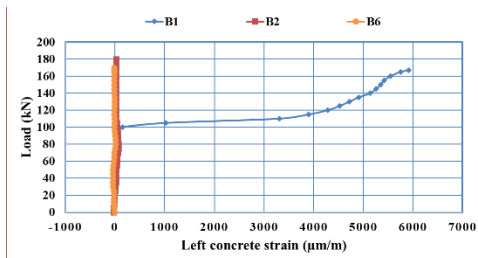
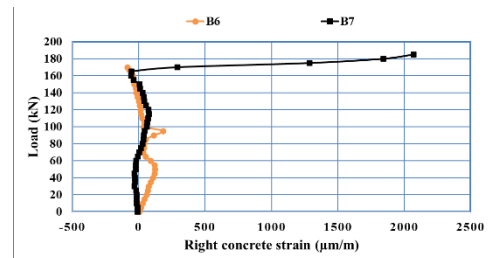
Fig. 7. Load strain relationship at left and right concrete shear zones for some selected beams.

a. Left side concrete strain for beams **B1**, **B2** and **B6**.

b. Right side concrete strain for beams **B6** and **B7**.

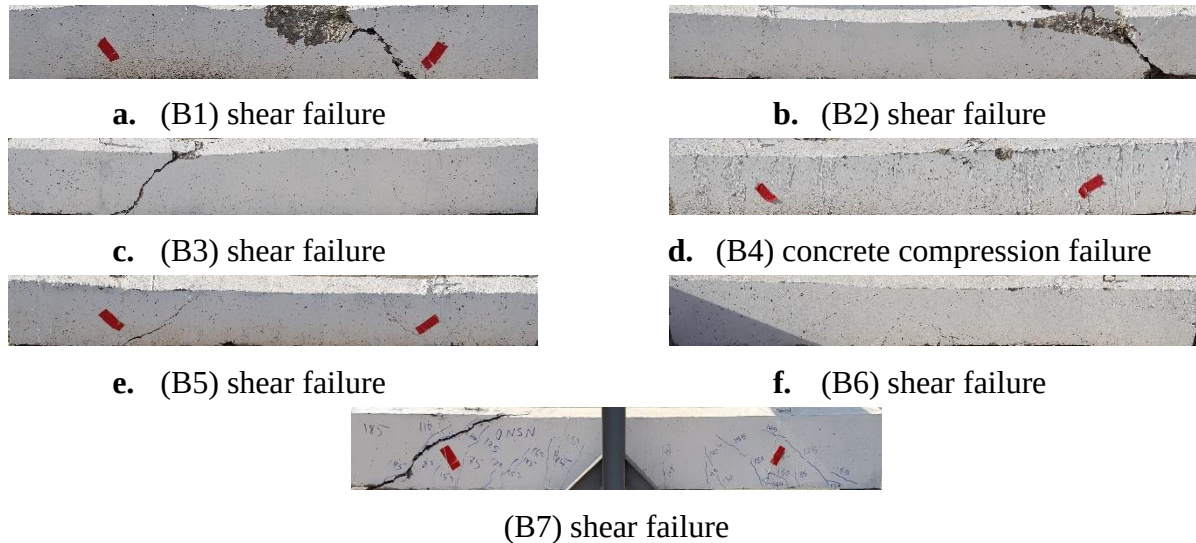
Fig. 8. Failure modes of all tested beams

Failure of beams B1 and B2 (that had the same strengthening pattern) was shear failure followed concrete crushing. The shear crack was started from the crushing of concrete confined between the top of the inner GFRP bar with the bottom of the outer GFRP rod, passing through the middle bar. Failure of beams B3 and B5 (that had the same strengthening pattern) was shear failure. The cracks were confined between the top of the inner GFRP rod and the middle of GFRP rod. Failure of beam B4 was a concrete crushing failure, there is no clear shear crack appear at the concrete shear zone, that is due to the small spacing between the strengthening GFRP bars compared to the distance used for other beams. Failure of beams B6 and B7 (that were tested without strengthening) was shear failure. The cracks were started from the applied point load toward the point of support. The crack width of the beam B7 was greater than the crack width of beam B6. As shown in Figure 8.
